ta-C Coating Found to Prolong Lifespan of End Mill With Better Finished Milling Surface

Nanofilm Technologies International Pte Ltd

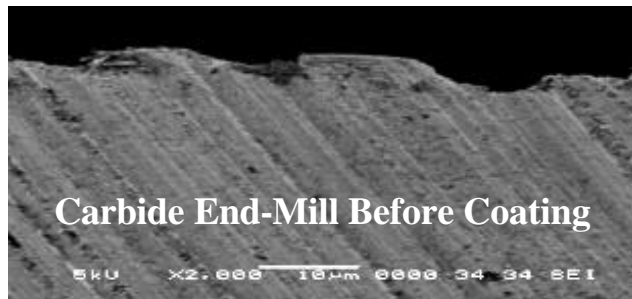
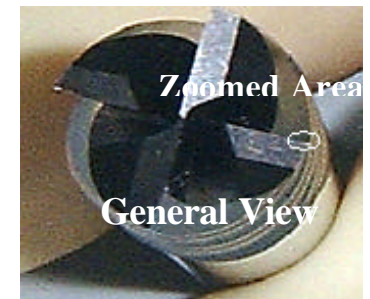
Before Test

- Uneven edge of the top flute is observed

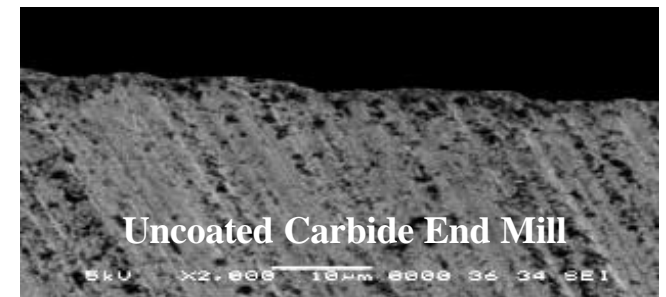
After 2 Hours of Milling with Uncoated Carbide End Mill

- Severe wear is observed on the top flute (the edge is flattened)
- Texture line on surface is damaged
- Surface becomes rough

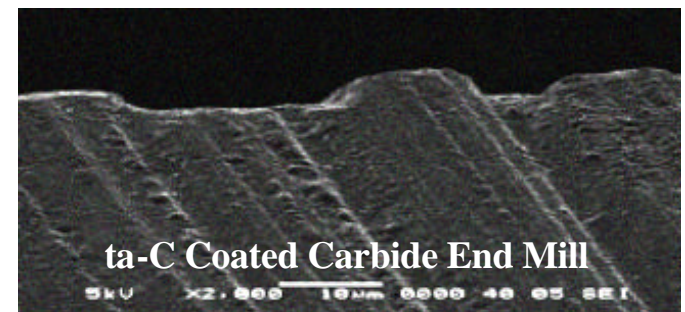
After 4 Hours of Milling with ta-C Coated Carbide End Mill

- Minimum wear is observed on the top flute (the edge remains about the same as the uncoated one before test)
- Texture line on surface remains intact
- Surface is still smooth

Rotating speed: 1400rpm
Feeding speed: 100mm/min
Milling depth: 5mm

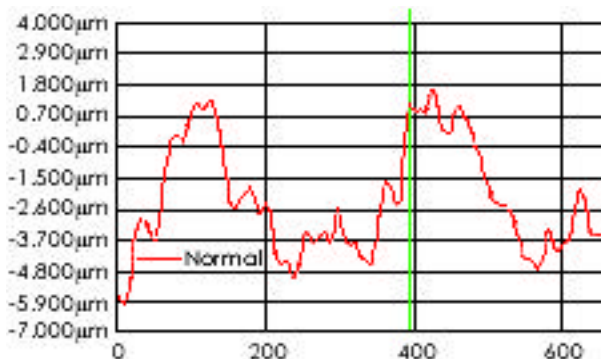
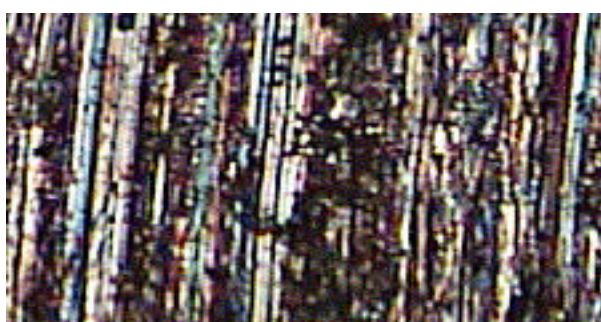
Milling with Uncoated End Mill

Peak to trough roughness: ~5µm
Distance between milling grooves: ~300µm

Surface Morphology of Al Block with Uncoated & Coated Carbide End Mills

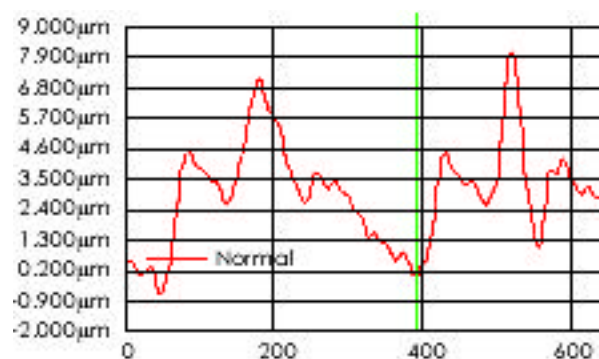
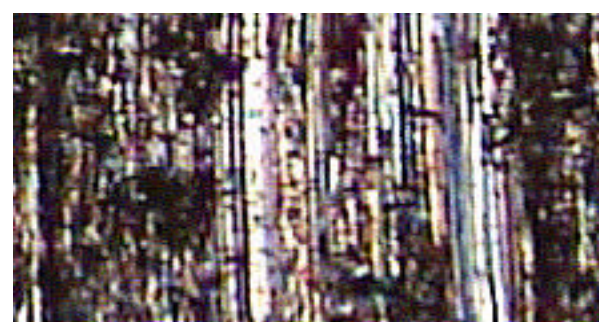
After 2 Hours of Milling with Uncoated End Mill

Peak to trough roughness: ~8µm
Distance between milling grooves: ~300µm

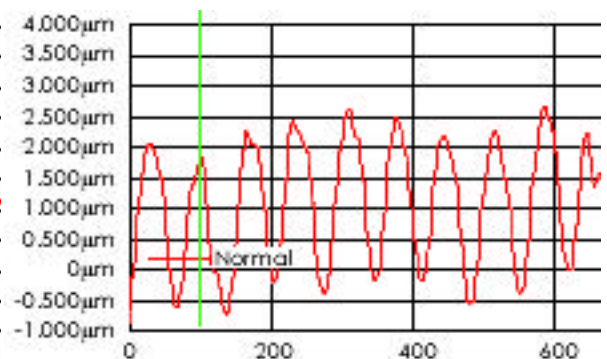
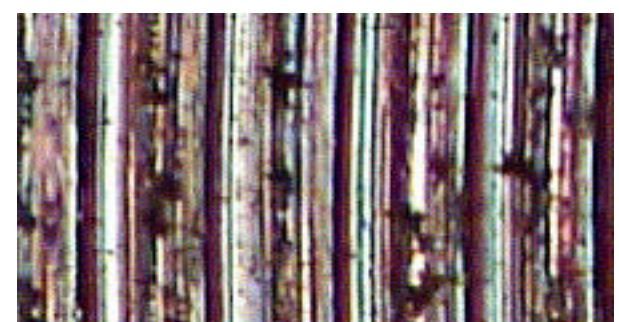
After 4 Hours of Milling with ta-C Coated End Mill

Peak to trough roughness: ~2.5µm
Distance between milling grooves: ~70µm
